PIPELINE PROTECTION AND EXTENSION OF INTERNAL COATING LIFE

Dr J Sargison

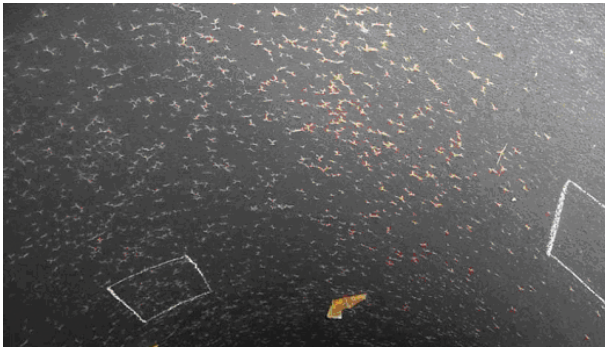
Figure 1: Distribution of internal pipe lining cracking over the crown of the pipe

Figures 1 and 2 show the typical degradation of the coal tar enamel coating. Once cracks are initiated in the lining, water is able to penetrate the lining and significantly increase the rate of failure of the coating. The initial cracking stage is hydraulically undesirable because it causes an increase in effective roughness of the pipe surface and therefore friction and hence headloss in the pipe are increased significantly. Further degradation due to ingress of water causes coating failure due to sections of coating losing adhesion to the pipe wall. This becomes

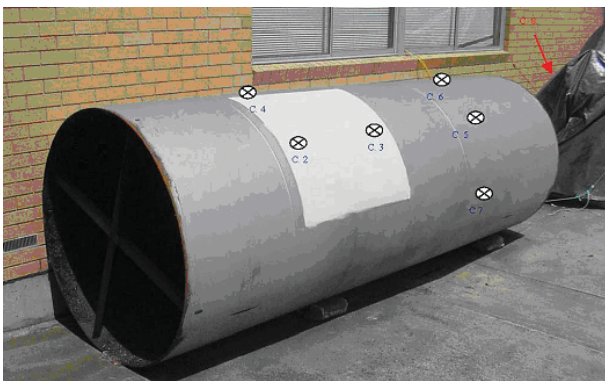
Figure 3: Pipe section in car park. Thermocouple locations indicated.

The thermocouples were located in the arrangement shown in Figures 3 and 4 behind the heat reflective coating and behind the existing coatings across the crown of the pipe. The local ambient temperature was also monitored away from the pipe in a shady, well ventilated region. Figure 5 shows the thermocouple attached to the wall using tape. The thermocouples behind the reflective paint were located 260 mm (channel 2) and 390 mm (channel 3) from the edge of the painted section. It is likely that due to the conduction of heat in the pipe wall, there may be some edge effect, causing the measured temperature to be higher than would be the case if the entire pipe section in direct sunlight were coated with the reflective paint. This

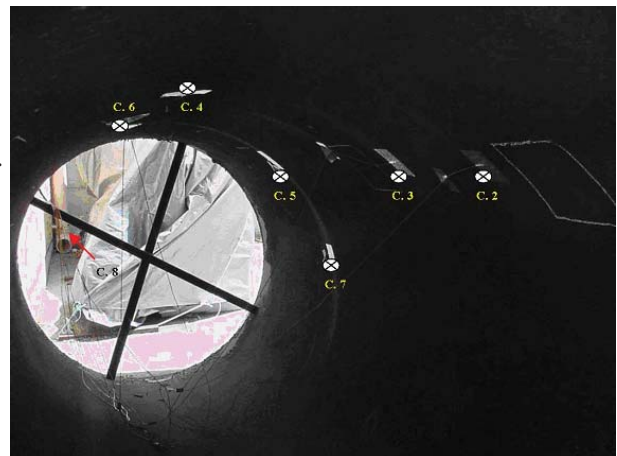
Figure 4: Pipe interior showing thermocouple locations.

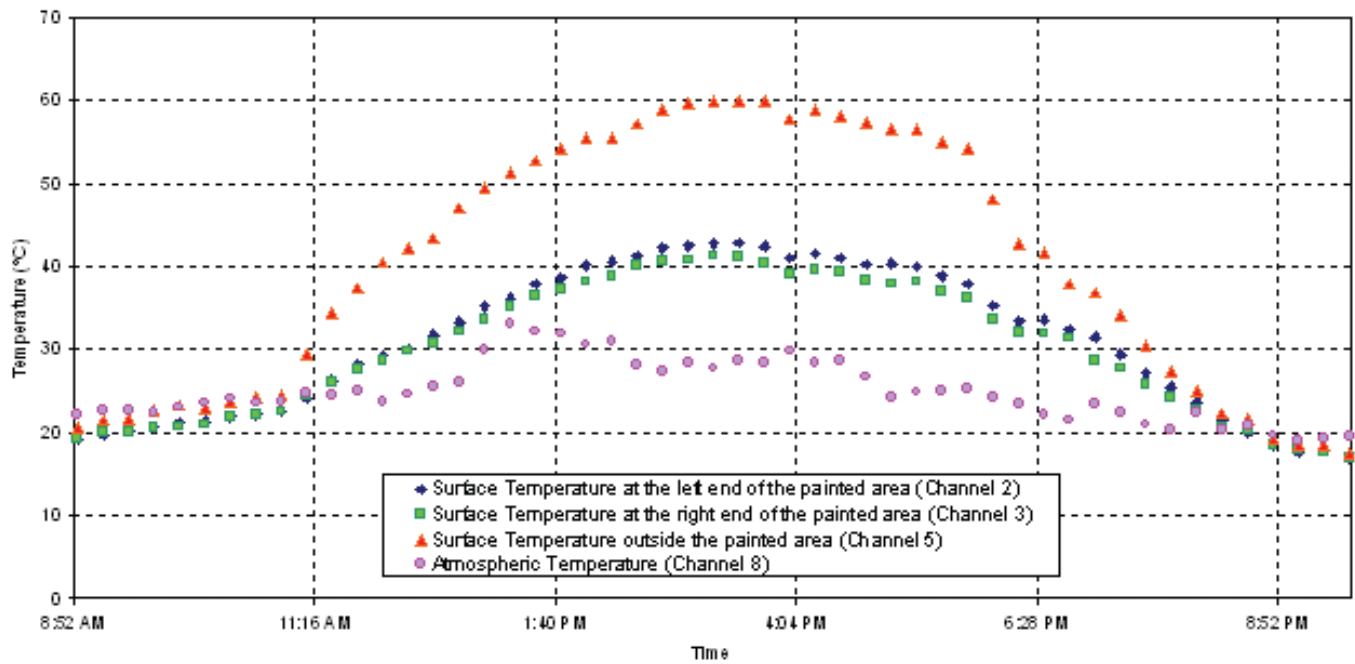
Pipe Internal Coating Surface Temperature Measurement (Data recorded at 7/1/2003)

Figure 6: Recorded Temperatures 7/1/2003 (Hot, Sunny Day)

is demonstrated by the experimental results in Figures 6-7, where the channel 3 thermocouple, located further from the edge of the painted section, records a measurably lower temperature (1-2°C) than the channel 2 thermocouple, located closer to the edge of the painted section. Thermocouple channels 2-4 monitored temperatures behind the heat reflective paint, channels 5-7 monitored temperatures inside the unmodified pipe section and channel 8 monitored the ambient temperature in the shade

The temperature measurements are shown in Figures 6 and 7. The typical diurnal temperature variation is visible, and results are shown for a sunny day (Figure 6) and a cloudy day (Figure 7). All samples

The key observation is the increase in the pipe internal temperature of up to 30°C above local, ambient temperature when exposed to direct sunlight. This significant temperature increase would expose the internal lining to temperatures well above the normal operating range (when filled) of 5-10°C. The performance of the section covered with the new heat reflective coating exhibits a markedly reduced temperature increase of 10-12 °C above ambient temperature. This level of performance has been recorded by other studies, for example Moujaes and Brickman [5], which review the cooling advantages of using these coatings to reduce heating load on buildings. This demonstrates that by correct selection of material used in the management of pipelines, the problem of extreme temperature can be mitigated.

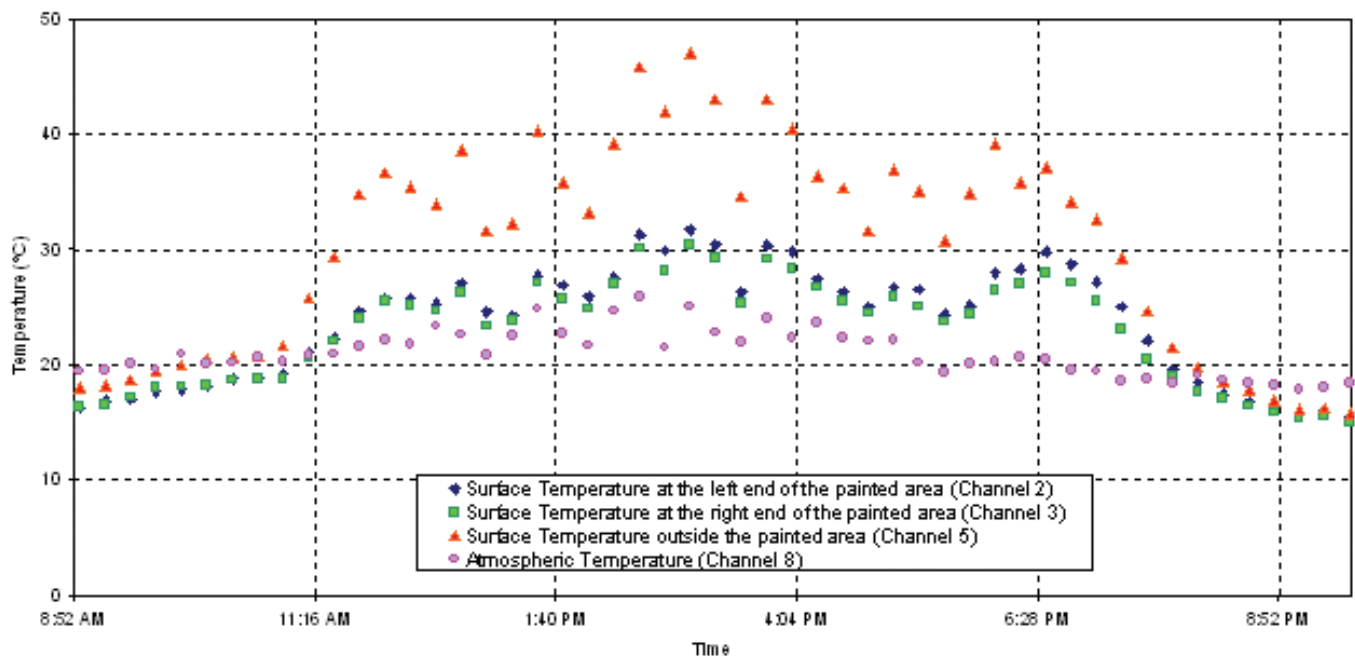
Pipe Internal Coating Surface Temperature Measurement (Data recorded at 8/1/2003)

Figure 7: Recorded Temperatures 8/1/2003 (Some Cloud)

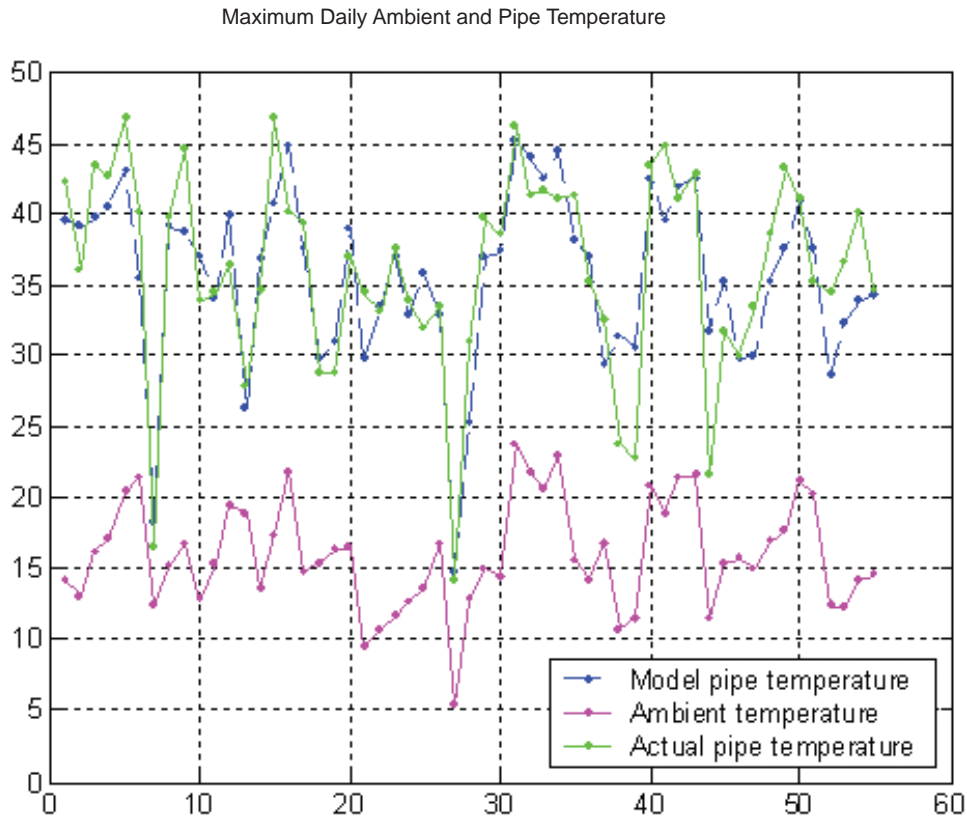
Figure 8: Comparison of measured results with thermal model prediction

Using measured values for solar radiation and ambient temperature (from weather station data), a Newton Raphson iteration technique [6] was used to determine the correct pipe temperature to balance this equation. Very good results were obtained with this simple model. A comparison of predicted maximum daily pipe temperature with data measured in the field in a long pipe

section is shown in Figure 8. In this situation an increase in pipe temperature of 25°C above ambient temperature was typical.
